Robbins Road overview mapping

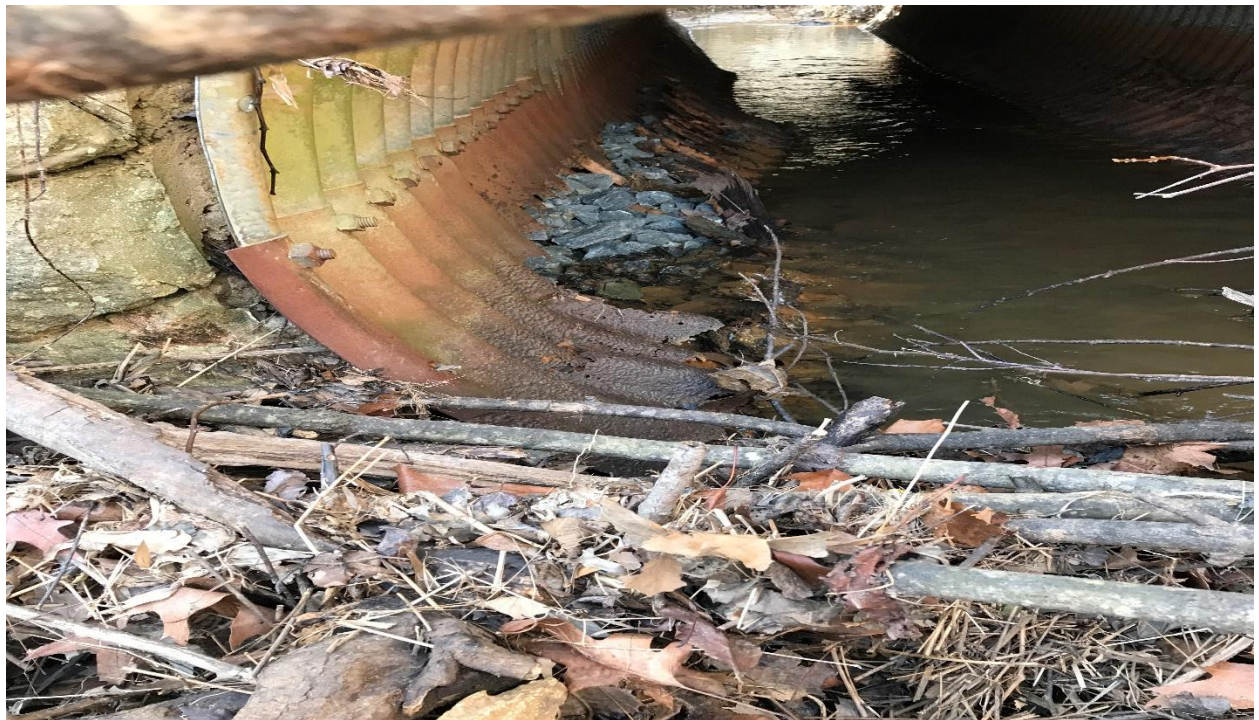
Upstream side of culvert (note: invert of culvert is gone)

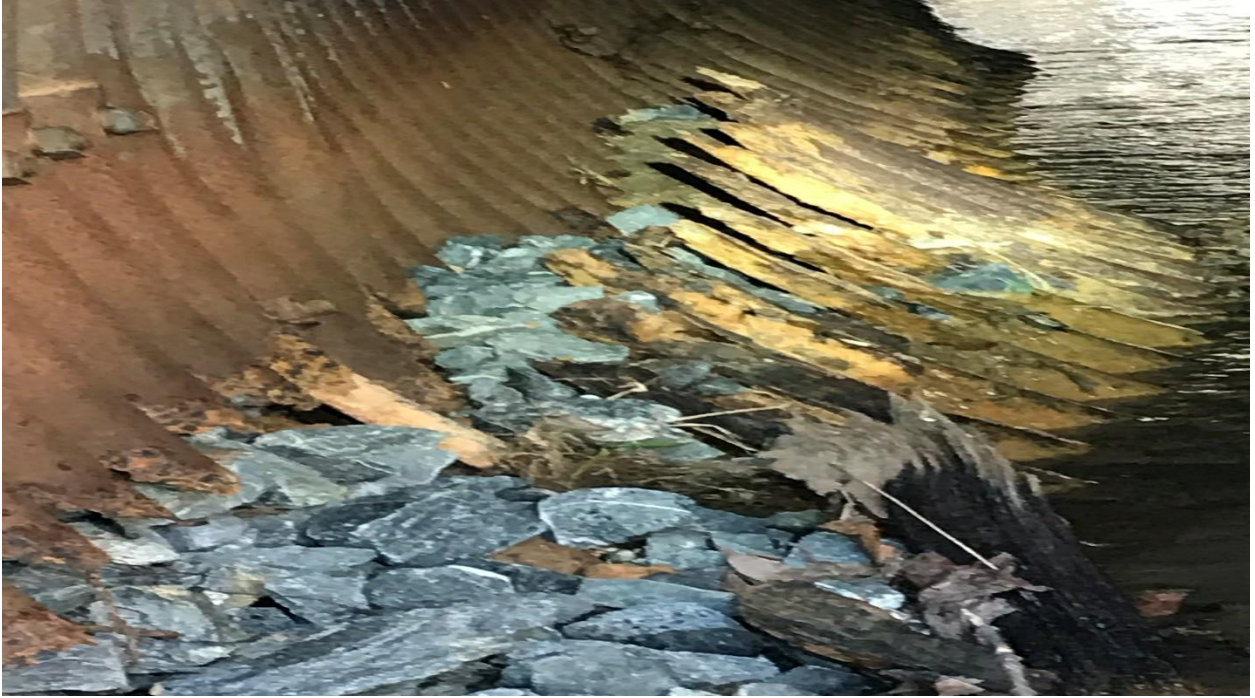
Stone placed in the voids to slow failure.

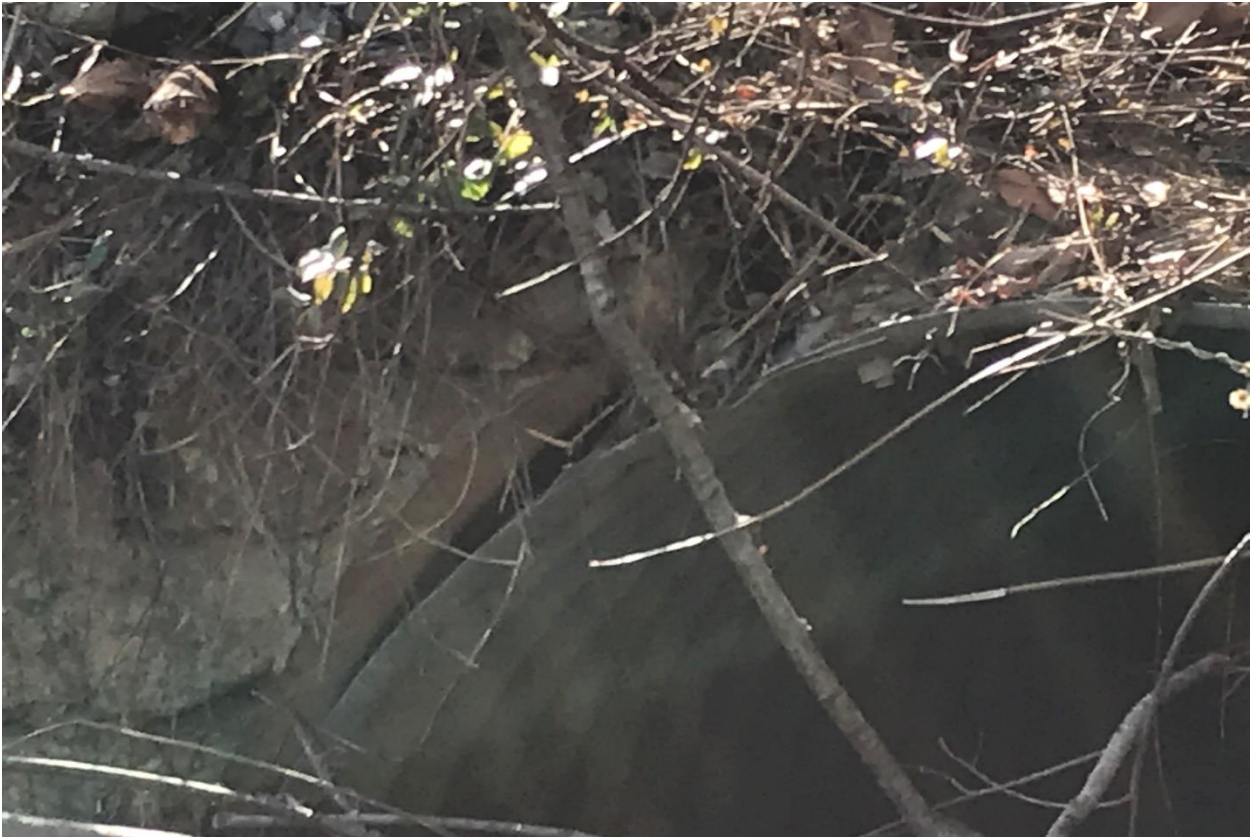
Pipe pulling away from the surrounding soil.
