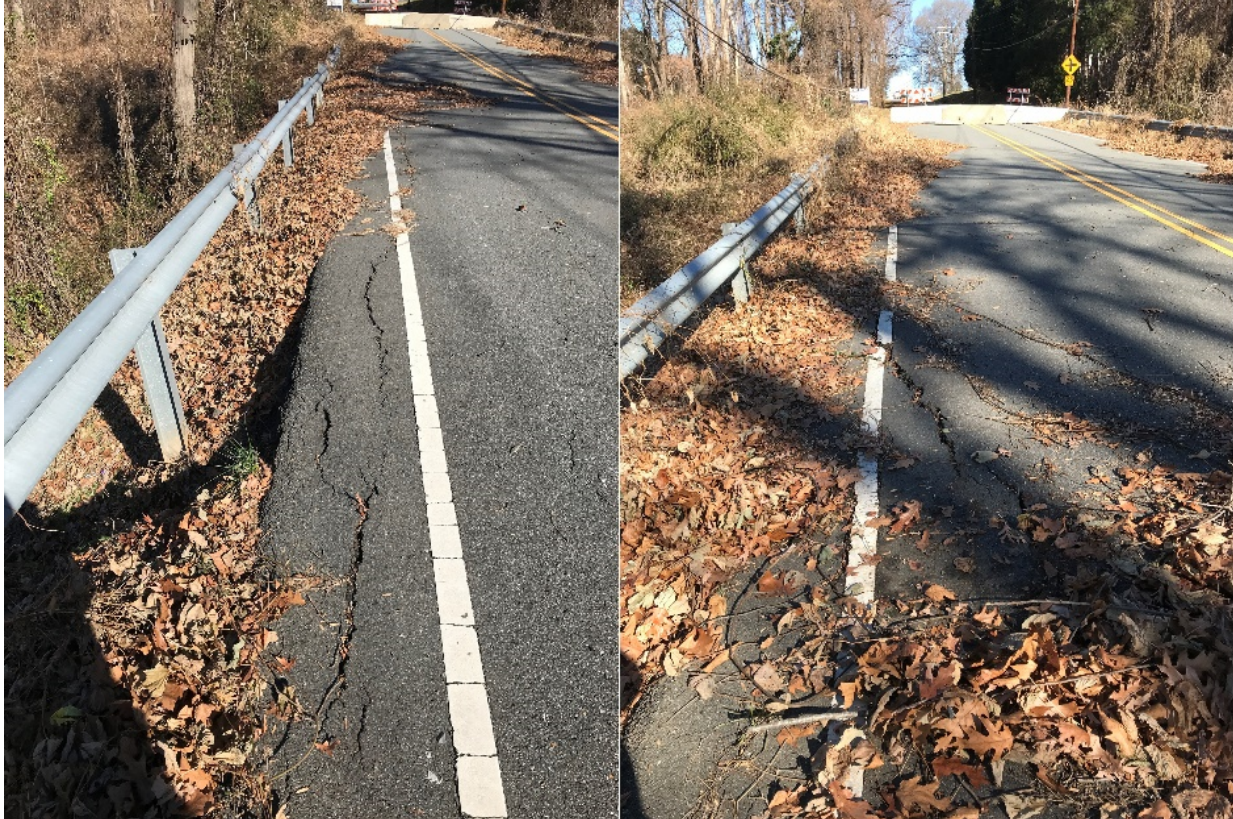
Longitudinal cracking and undermined guard rail along edge - Work Area A

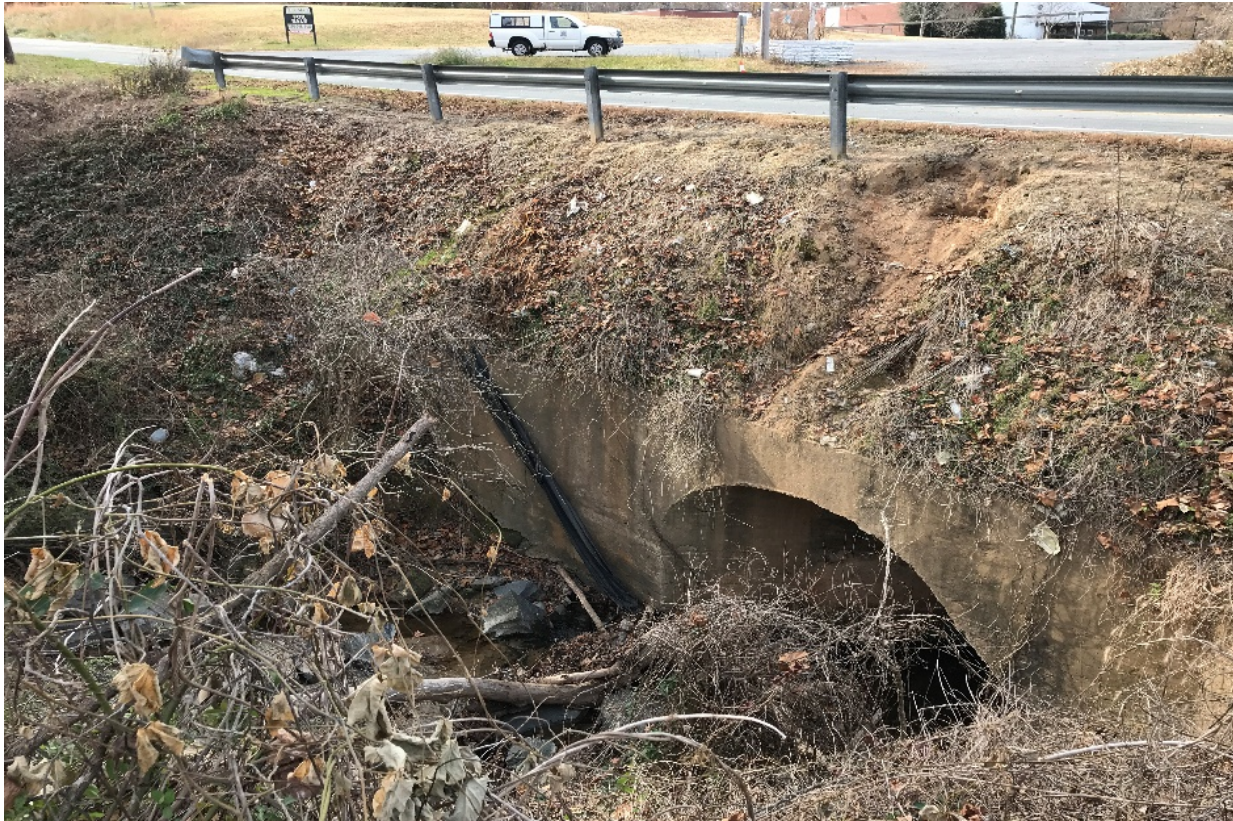
Eroding slopes over box culvert – Work Area B
