# DRAINAGE INFRASTRUCTURE UPDATE

PUBLIC WORKS COMMITTEE
April 12, 2022

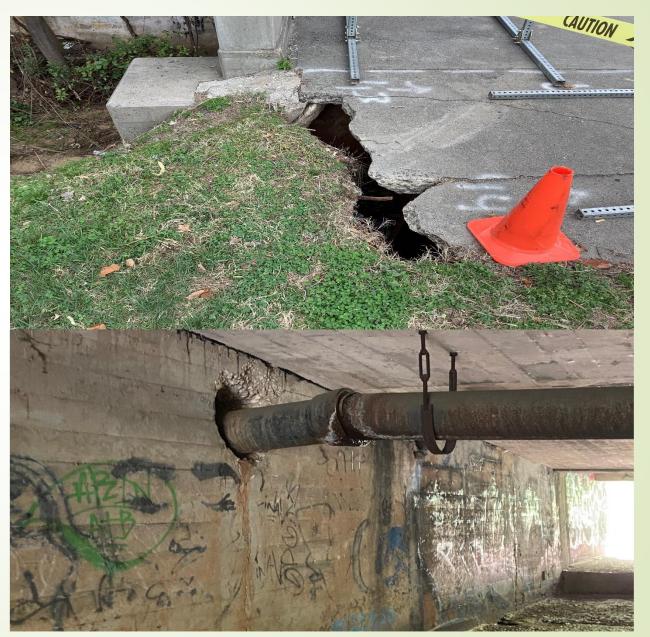
- Culvert: Hawthorne Road
- Ward: Southwest
- Damages: culvert settlement, shifting, invert undermining,
- Approximate Replacement Cost: \$ 3,000,000
- Emergency contract in place with consultant. Alternatives analysis complete. Full culvert replacement needed.

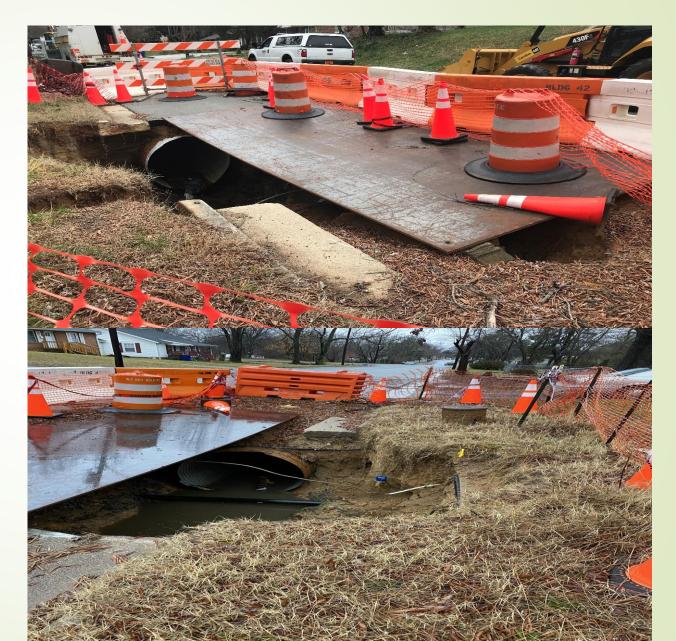
- Culvert: Devonshire Road
- Ward: Southeast
- Damages: 48" corrugated metal culvert invert corrosion resulting in sinkholes within travel surface of Devonshire.
- Approximate Replacement Cost: \$ 350,000
- In-house drainage crew will make temporary repairs. CIP project needed for full replacement.

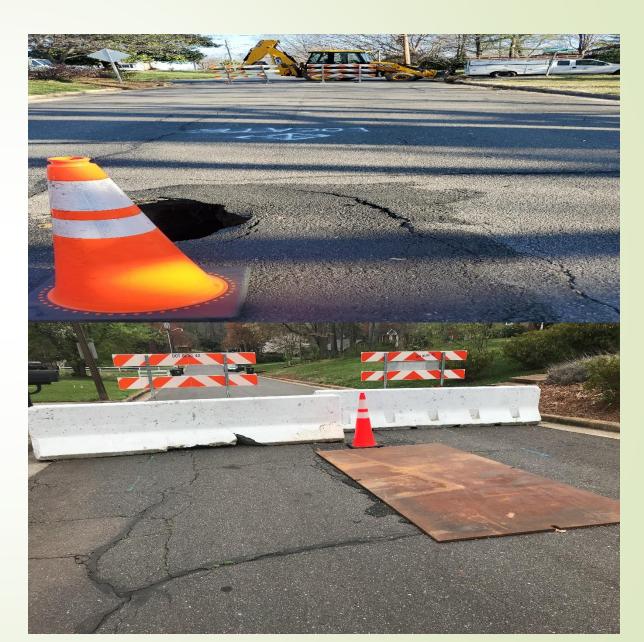
- Culvert: Lynnhaven Road
- Ward: West
- Damages: 24" corrugated metal culvert invert corrosion, resulting in sinkholes in the road.
- Approximate Replacement Cost: \$ 700,000
- In-house drainage crews have plated and closed the impacted road segment. CCTV of drainage system complete. CIP project needed for full replacement of drainage system.

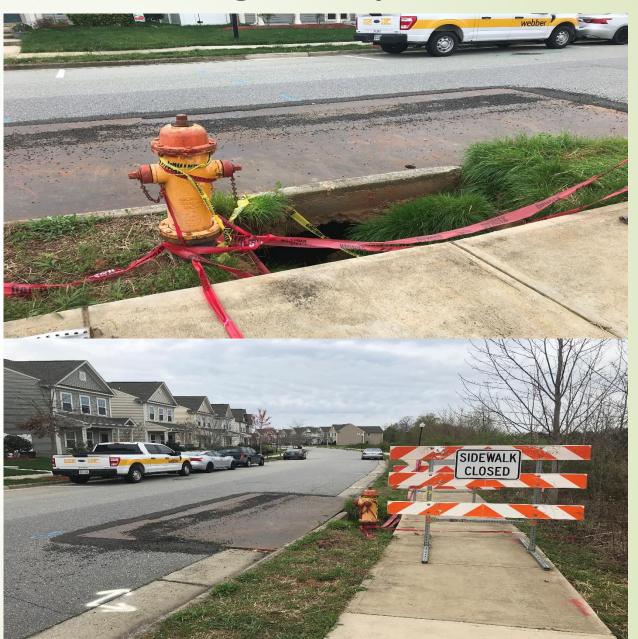
- Culvert: Autumn Mist
- Ward: Southwest
- Damages: 24" concrete pipe separated resulting in large sinkhole in travel surface of Autumn Mist.
- Approximate Cost: \$150,000
- Inhouse staff have CCTV'd the line and are making repairs in order to allowingress/egress to residential homes.

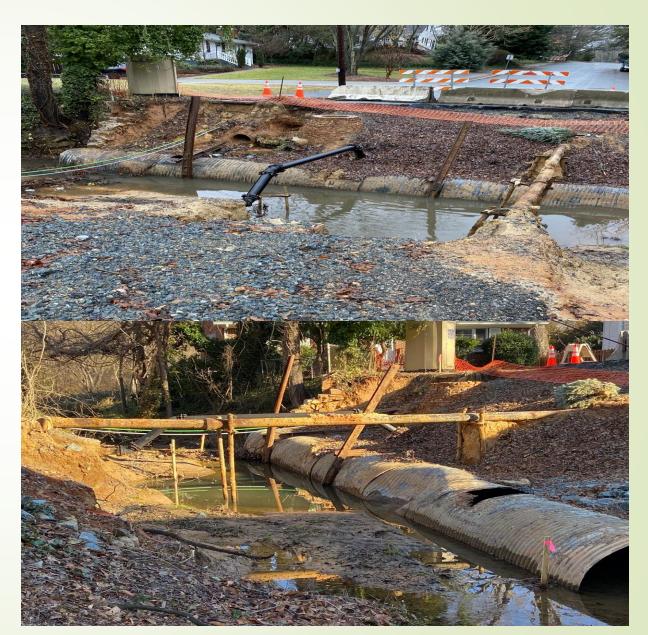
- Culvert: Maplewood Ave
- Ward: Southwest
- Damages: Two 54" metal pipes have collapsed resulting in road closure.
- Approximate Replacement Cost: \$700,000
- Staff are working with contractor under emergency provisions to replace the drainage system. Working with property owners to acquire easements.

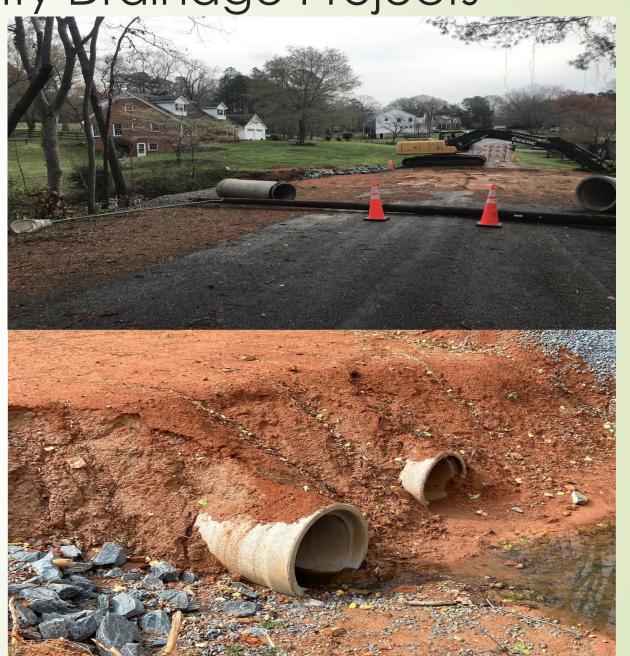
- Culvert: Aubry Court
- Ward: Northwest
- Damages: Road closed due to infrastructure and impoundment failure.
- Approximate Repair Cost: \$300,000
- Inhouse crews are working to make repairs as staffing allows. Failed piping has been replaced and headwalls and road surface are outstanding.

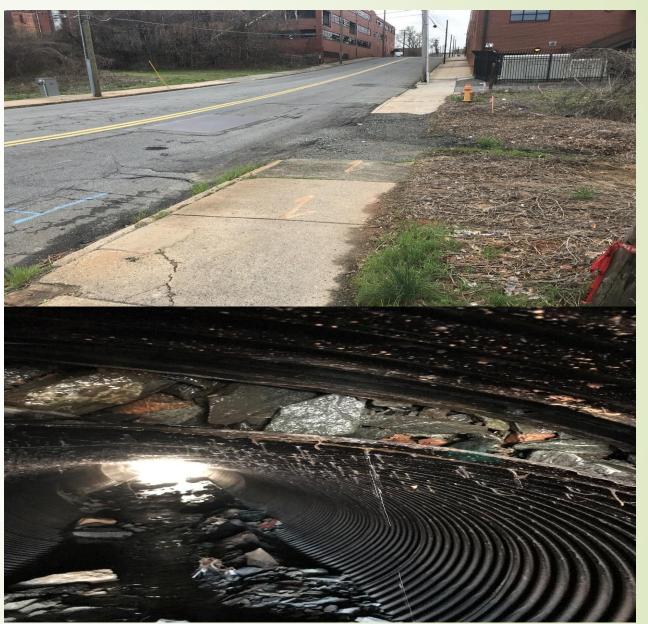
- Culvert: Patterson Avenue
- Ward: Northeast
- Damages: 72" corrugated metal pipe damaged.
- Approximate Repair Cost: \$1,500,000
- Under emergency provisions, a design for replacement and construction permits have been obtained.
   Contractor to mobilize May 9<sup>th (depending on material availability)</sup>.

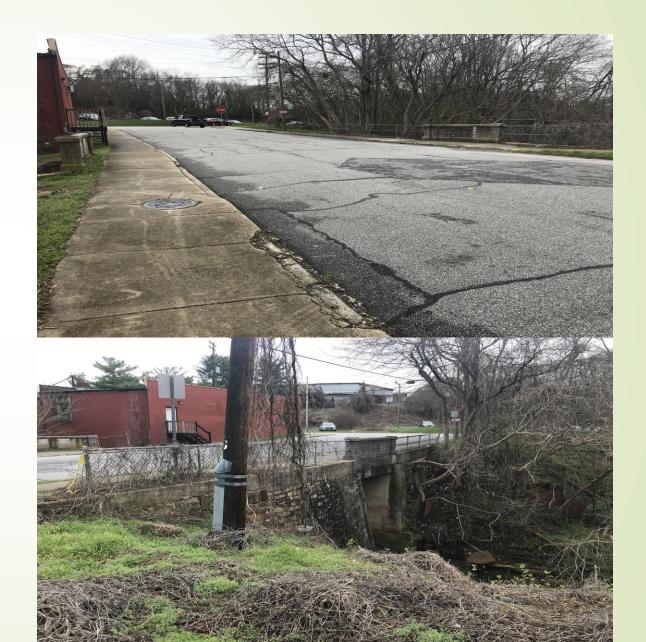
- Culvert: Underwood Avenue
- Ward: North
- Damages: 20'x 20' concrete box culvert invert failure resulting in sinkhole at the curbline.
- Approximate Repair Cost: \$500,000
- Design for structural upfit underway. Inhouse staff have made temporary repairs to stabilize sinkhole.
