Building Assessment

2530 Pittsburg Avenue Northwest

Forsyth County - General Services Department

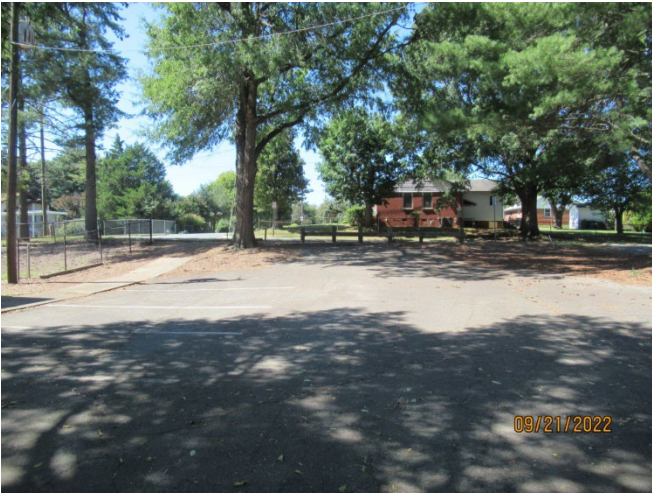
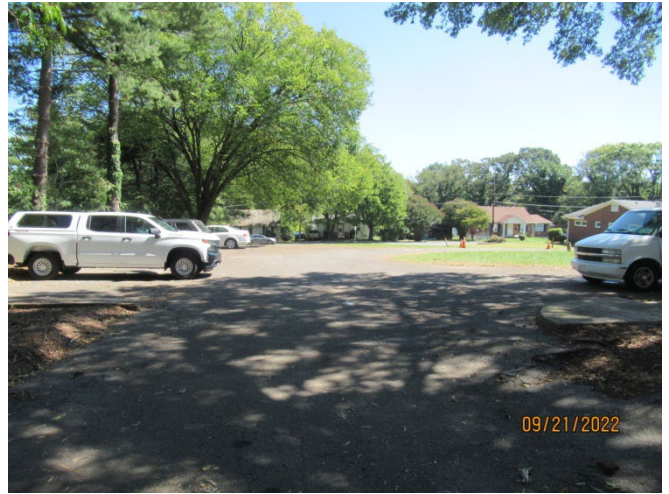
Parking lot: Severely distressed, recommend milling and repaving. Seal coating and patching would buy a few years of use.

- A. Parking lot striping: \$1500
- B. Asphalt paving: \$20,000
- C. Remove trees adjacent to the building. \$5000
- D. It is recommended to install a perimeter security fence. \$45,000

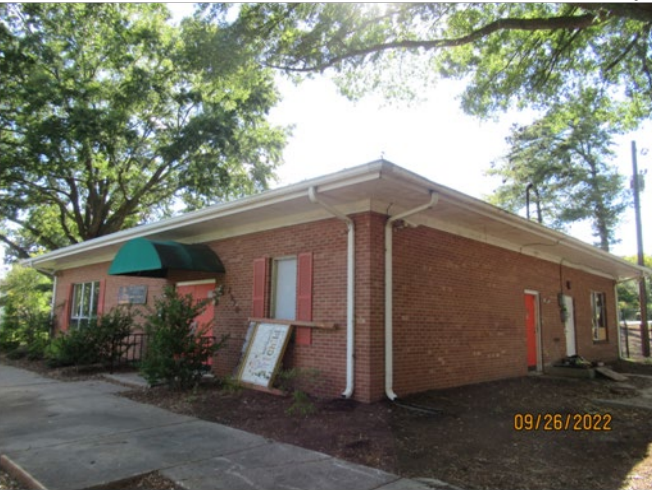
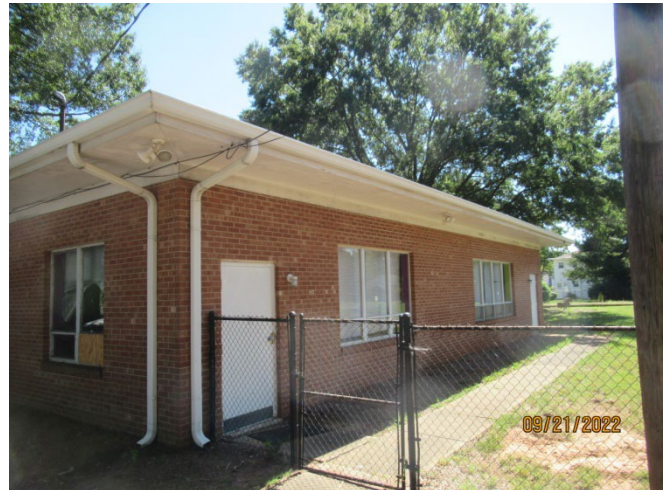
Facade View - Facade needs to be pressure washed / and exterior window are single pane and should be replaced for energy efficiency.

- A. Pressure washing. \$1500
- B. New windows. \$10,000
- C. Repair and paint the soffit around building. \$2500
- D. Reroofing (tear off to deck, new polyiso and single-ply KEE membrane) \$150,000 + reasonable contingency for deck repair and unforeseen/hidden conditions.
- E. New gutter drainage system. \$500

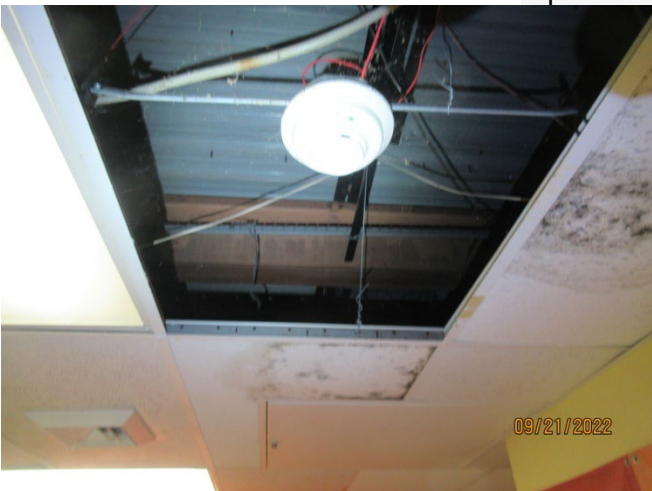
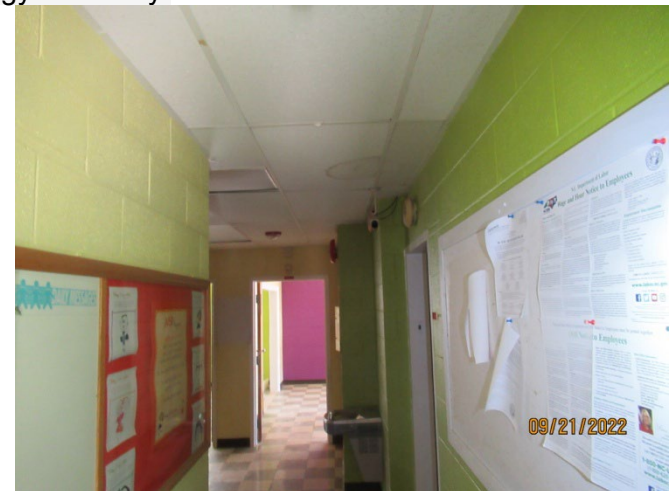
View of interior ceilings - Needs to be replaced due to leaks.

- A. Replace acoustical ceiling system. \$18,000
- B. Existing VCT – asbestos abatement. \$4,000 (abatement only)
- C. New interior, exterior doors with hardware. TBD by tenant upfit.
- D. Paint all the walls. TBD by tenant upfit
- E. Install new flooring. TBD by tenant upfit.
- F. Patch all existing walls, 2 finish coats of paint to walls and trim. TBD by tenant upfit.

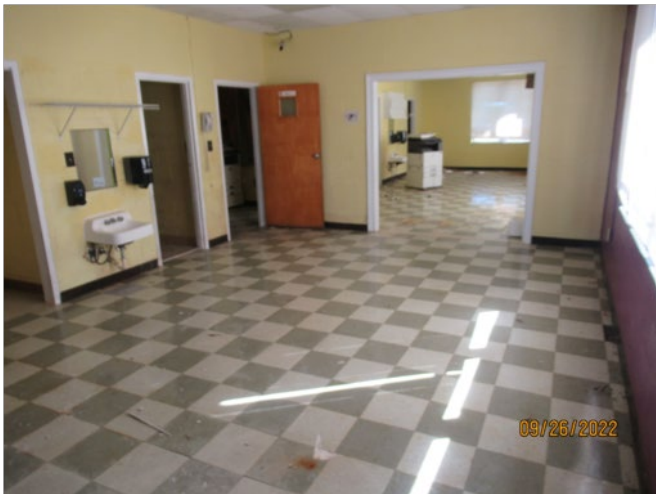
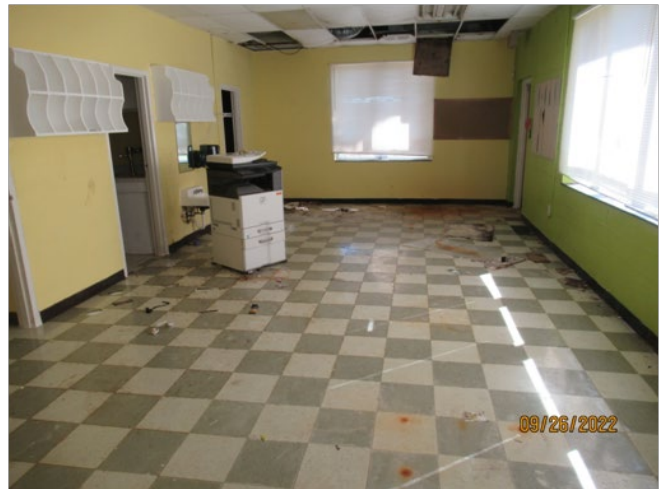
Interior floors are ACM and require abatement.

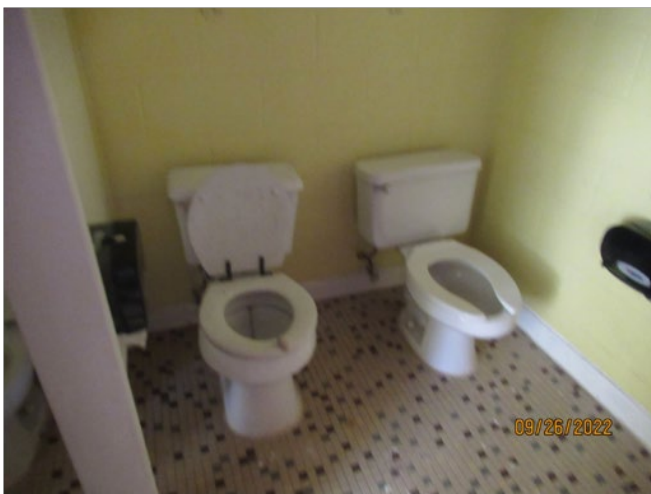
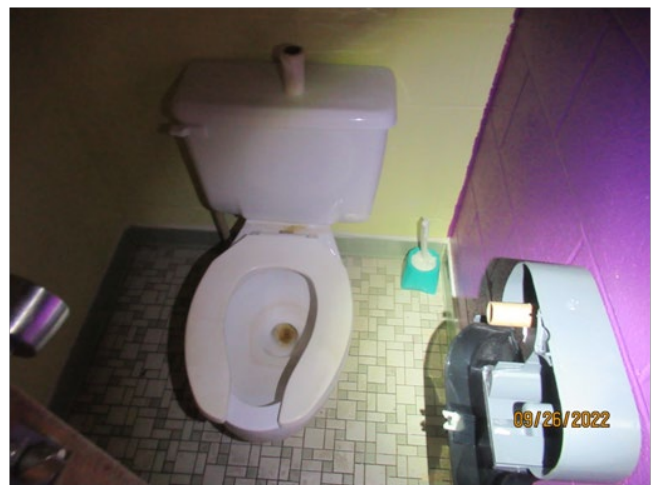
View of the conditions of the plumbing fixtures not ADA compliant.

- A. Bathrooms require updates to be ADA compliant. Currently fixtures are setup for children/daycare use.

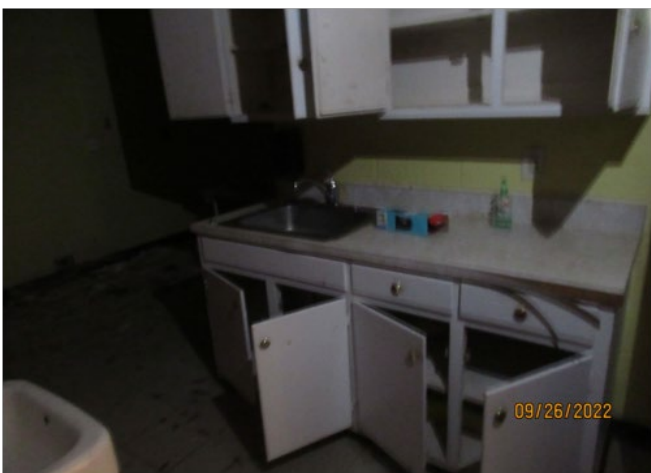
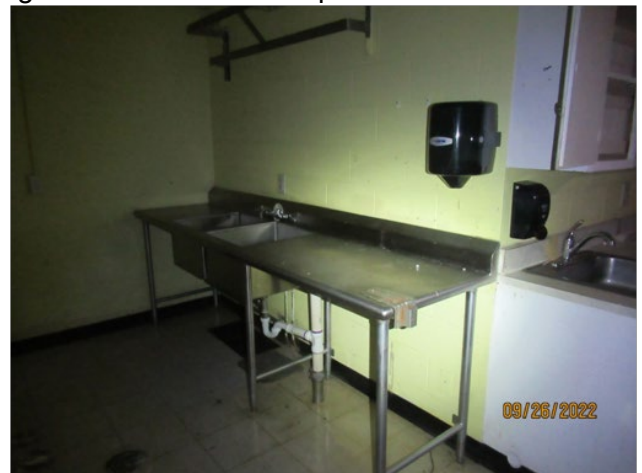
Kitchen area. Reuse may require changing the layout of this space.

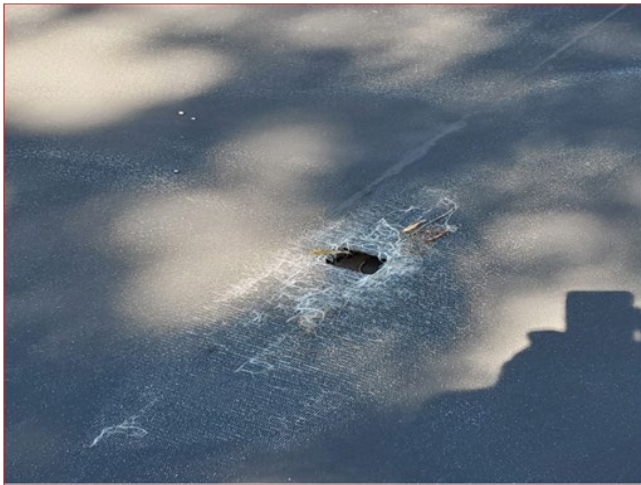
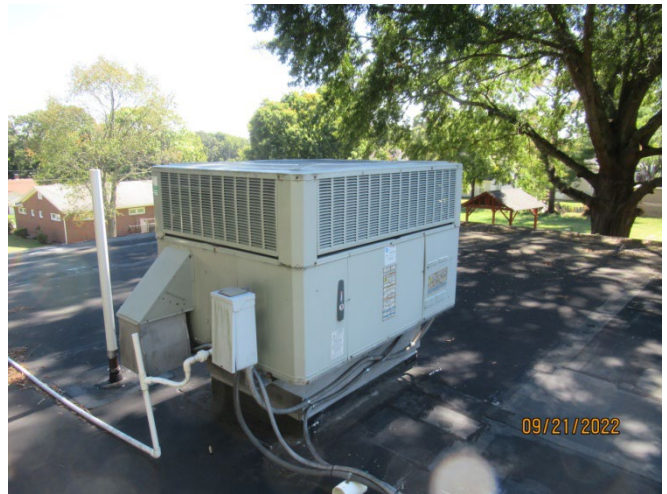
EPDM roof severely deteriorated and need of replacement. Due to the extremely poor roof condition, tear off to the deck is required to verify roof decking is structurally sound.

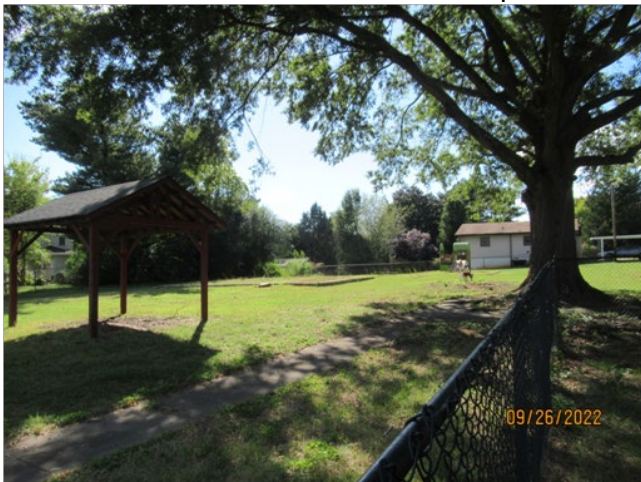
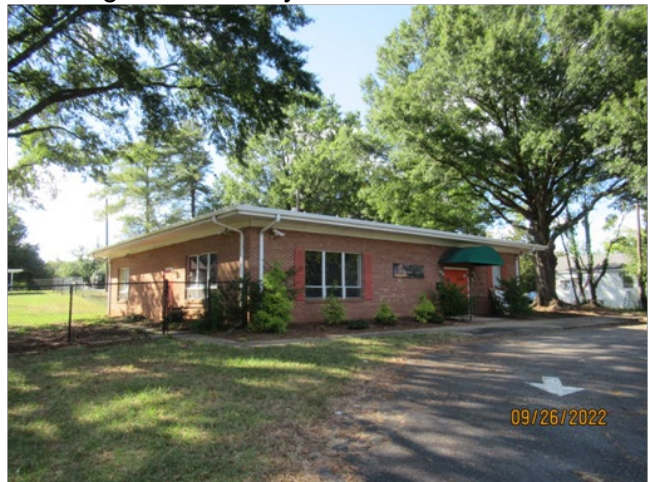
Large oak trees adjacent to the structure are blocking up roof drainage and could damage building foundations. Recommendation is to remove trees.
