PFM Building Condition Assessment U.S. Bankruptcy Court – 226 S. Liberty St. Winston-Salem

July 2019

226 South Liberty Assessment 2019

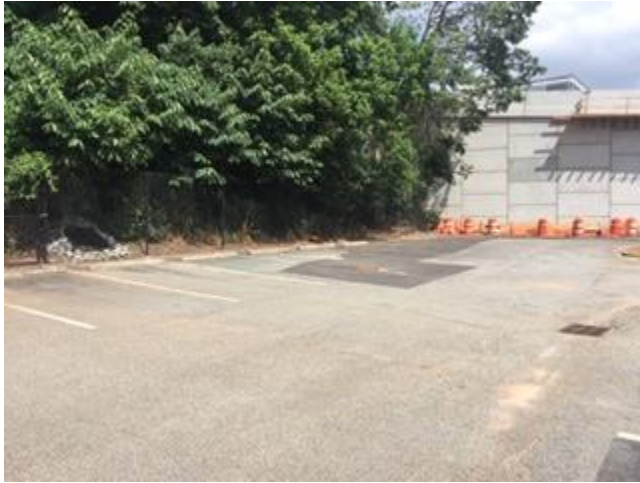
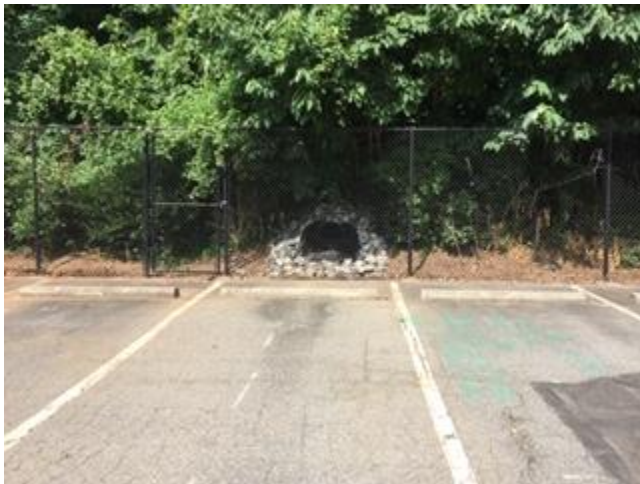
- Drainage on Eastern side of building coming off embankment could potentially overwhelm drains and cause flooding in parking lot.
-

Drainage concerns

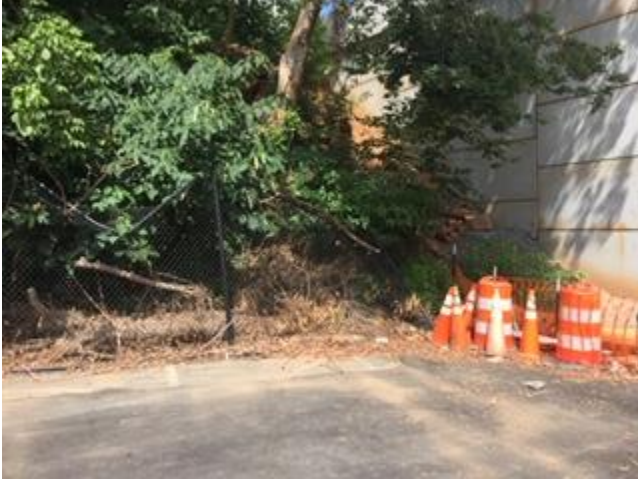
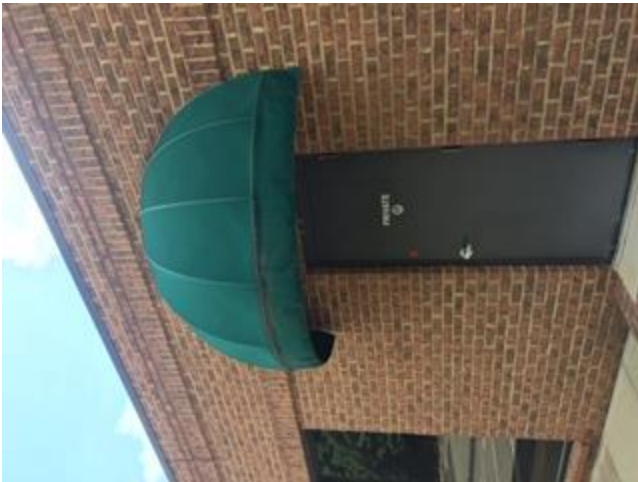
- Many gaps in fencing around perimeter of building do to road construction. Fencing will need to be repaired in various locations.
- Exterior Window Seals generally in good condition could use caulking in various locations.

Fencing issues:

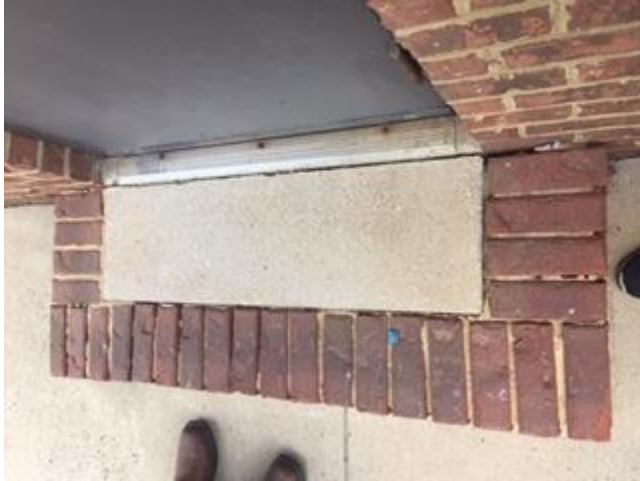
- All doors and hardware seem to be functioning and in good working condition
- East facing windows leading to main entrance appear to require re-glazing
Brick sills (six windows) need re-pointing

Miscellaneous Maintenance – Caulking or tuck and pointed needed

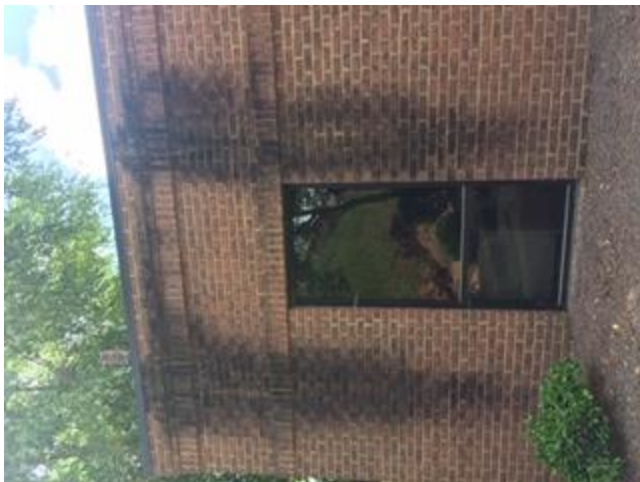
- Water runoff on exterior of building noticed on North facing side in one location. Cutting the trees back and replacing the roof will solve this problem.

Stains on North side of building as identified in report

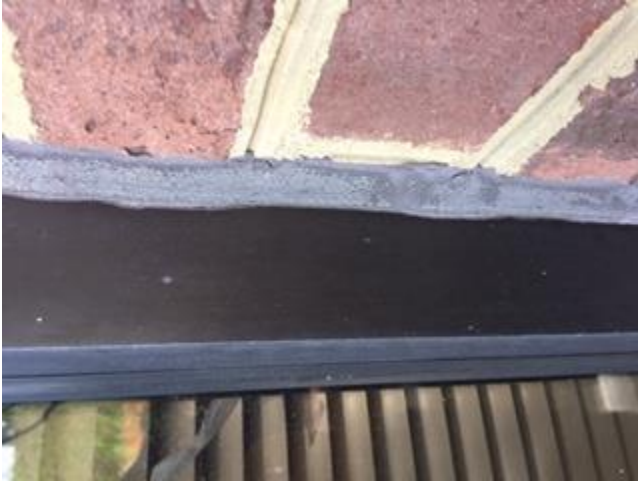
Window Seals in various locations need maintenance

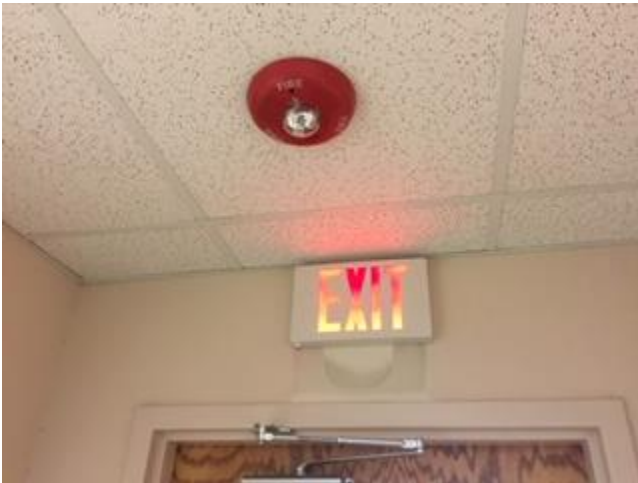
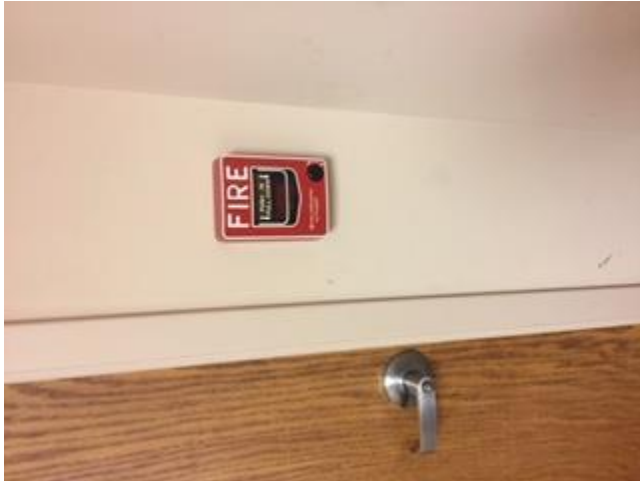
Fire Strobes, Pull & Stations Exit signs look to be in great condition throughout building.

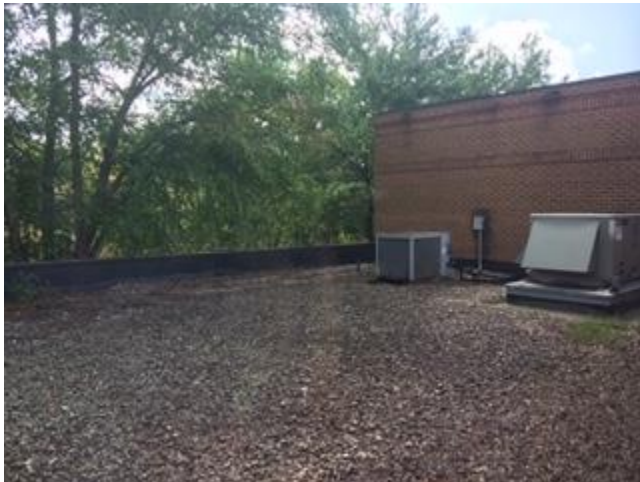
- (10) Total HVAC systems. (8) Trane Rooftop Heat Pump Package Units R410a installed 2008
- Mini Split – Fujitsu Unit on the roof (newer unit)
- Split system unit (Original Unit) which is no longer operational and has exceeded its useful life. Needs to be replaced
- HVAC Duct work issues upstairs on south end of the building will need to be addressed. There is not adequate airflow

HVAC unit that needs to be replaced (unit on left)

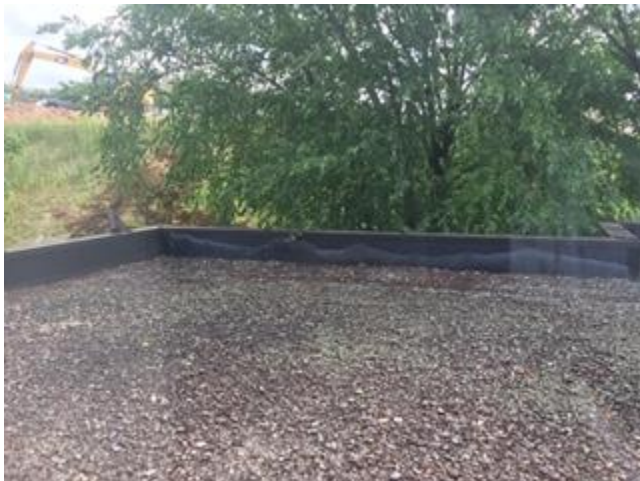
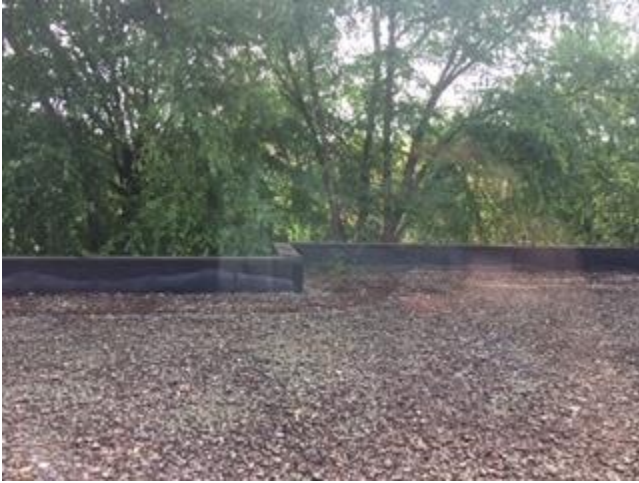
- Original roof 27 years old (Ballasted - EDPM) Roof has exceeded its useful life and needs to be replaced. This roof is not a candidate for coating. The EDPM is pulling away in many locations from the parapet wall.

EDPM pulling away from parapet wall in multiple locations throughout roof

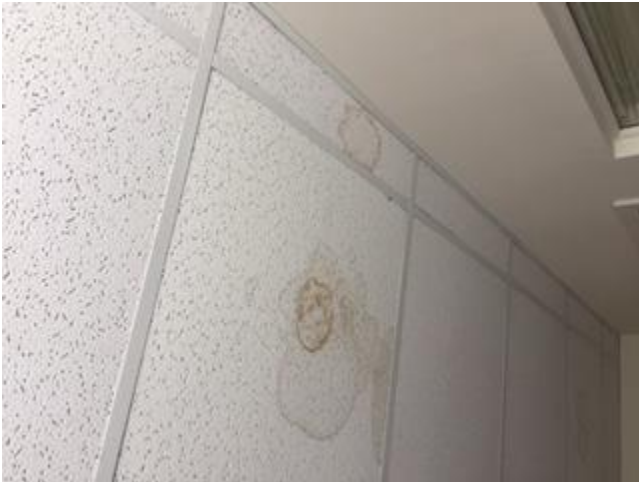
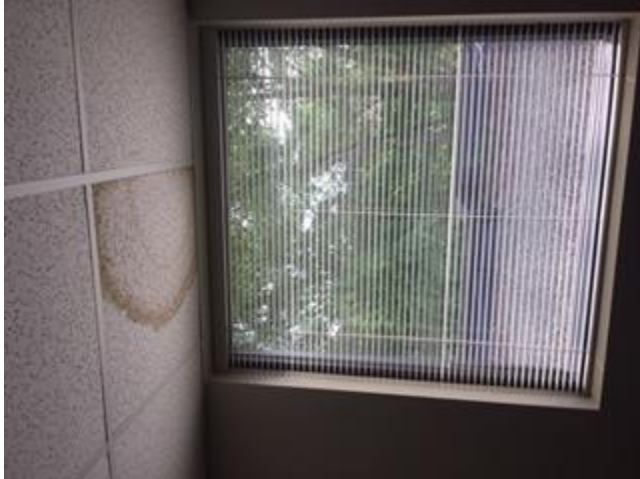
- Few damaged ceiling tiles from roof leaks. Stained. Need to be replaced after roof replacement.
- Ceiling Grid in overall great shape.
- 2nd Floor – Doors and Windows in Great shape. Couple of windows may need to be replaced (2) on the first floor and (1) on second floor. Seals failed on 3 windows - moisture is trapped in panes.

Damaged ceiling tiles from roof leaks

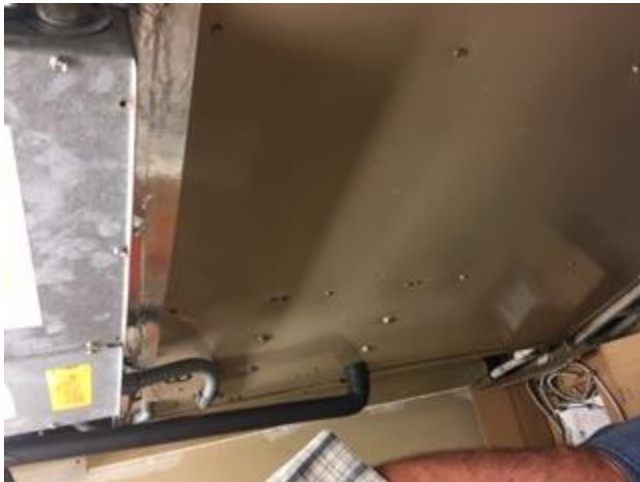
HVAC unit air handler that needs to be replaced.

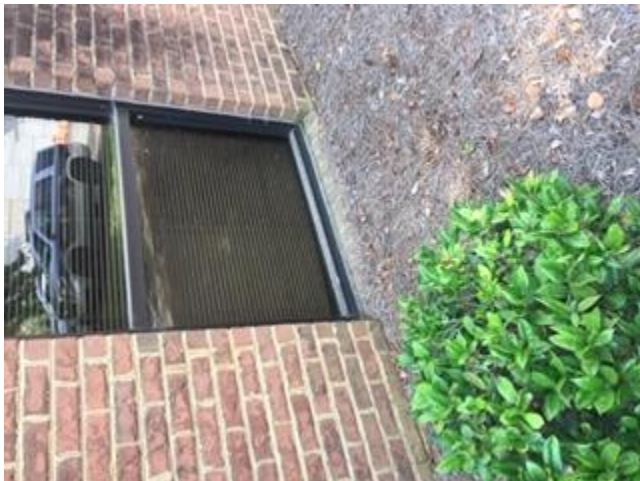
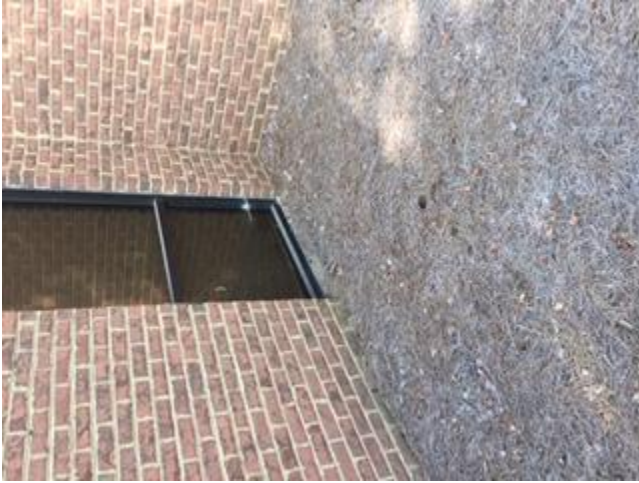
- Exterior window seals on north and eastern sides of the building are almost buried by exterior dirt and vegetation. Could cause leaks in future if not removed.

Base of windows need to be excavated to alleviate potential flooding

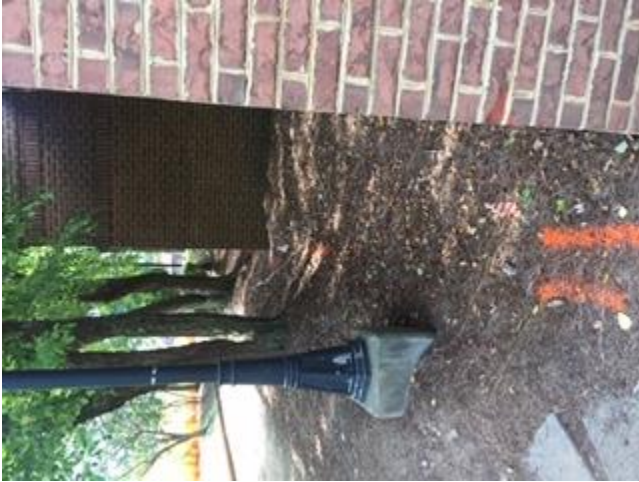
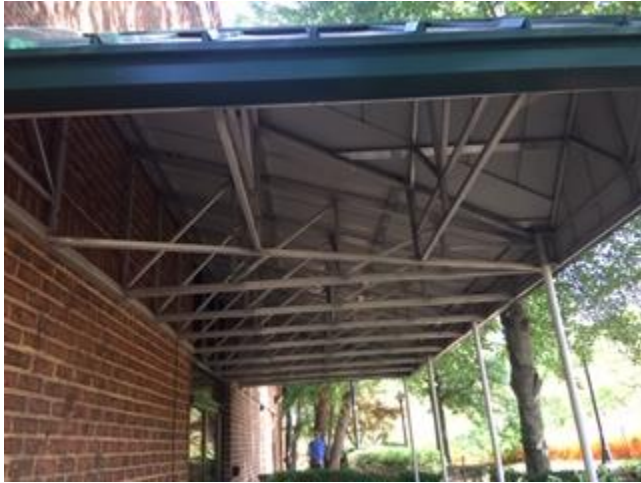
- We were not able to locate hot water heater. Above ceiling somewhere down stairs. Water Heater needs to be assessed.
- Exterior brick in good shape. A couple of spots with discoloration.
- All bathroom tile flooring and grout in good shape. No visible signs of repairs being needed.
- Vegetation around building needs to be trimmed back especially river birch trees located on eastern side of building.

Birch trees in close proximity to build could be potentially problematic to foundation in future.

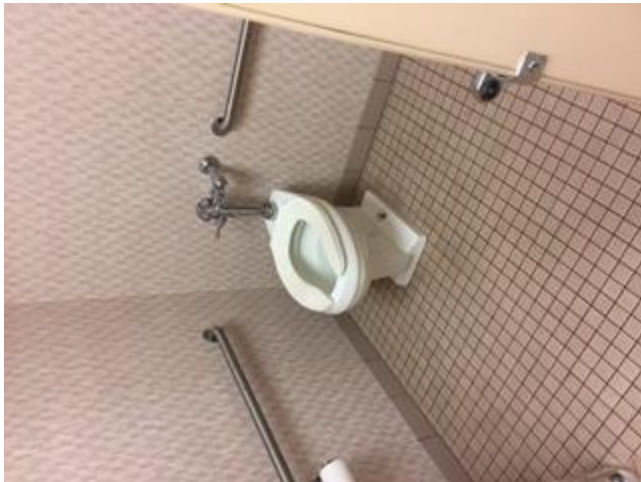
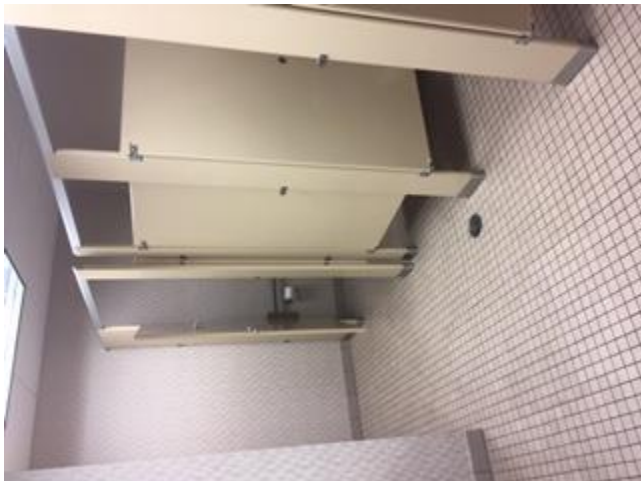
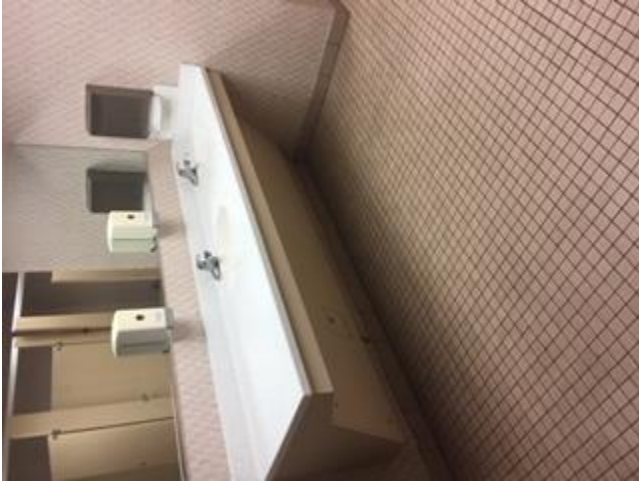
Commercial Toilets, Tile flooring, partitions in overall great shape

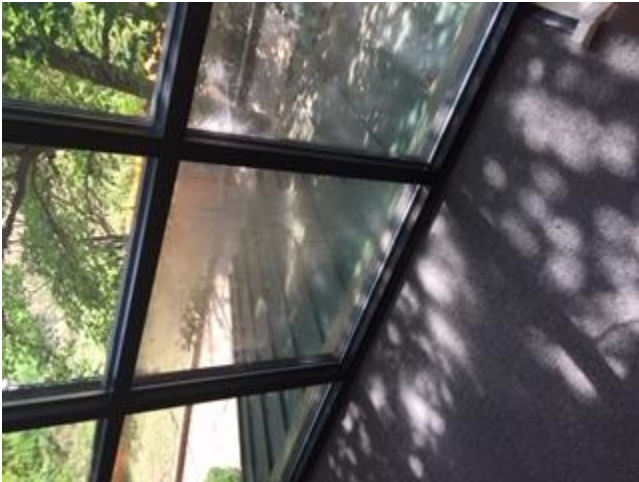
3 windows like this need to be replaced

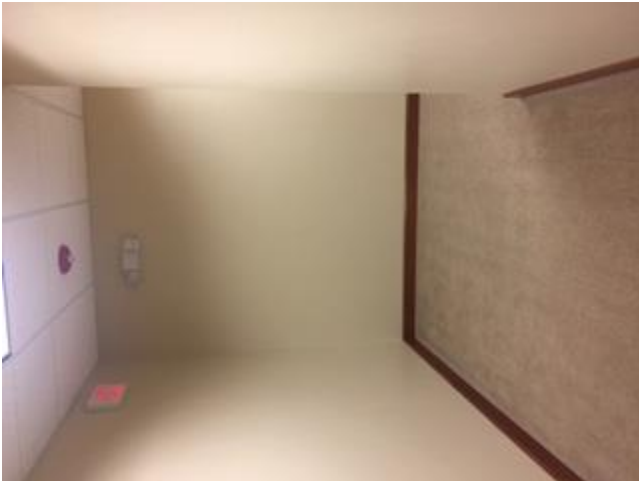
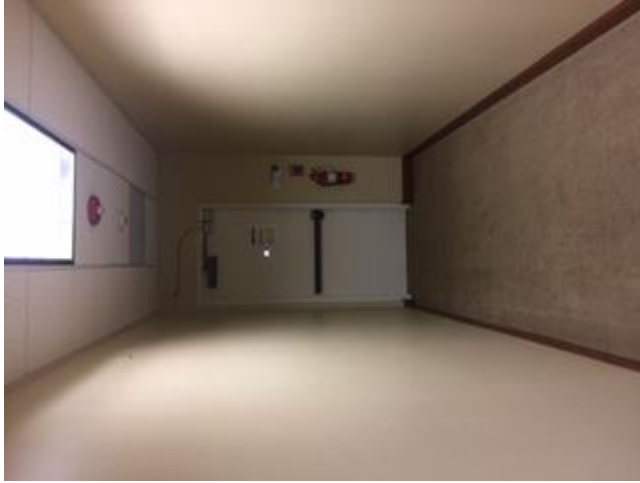
Base board and walls 1st floor in good condition.

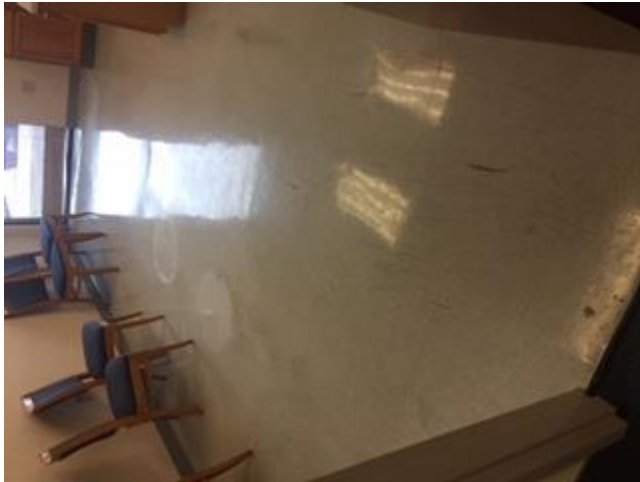
VCT floors could use stripping and waxing 1st floor break room

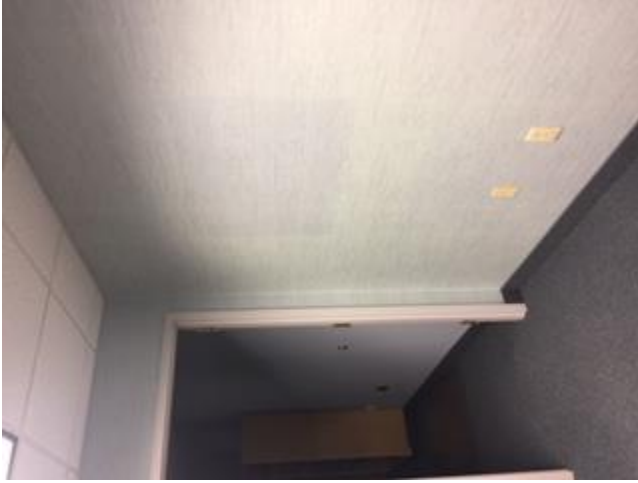
Vinyl Wall Covering in great shape 1st floor

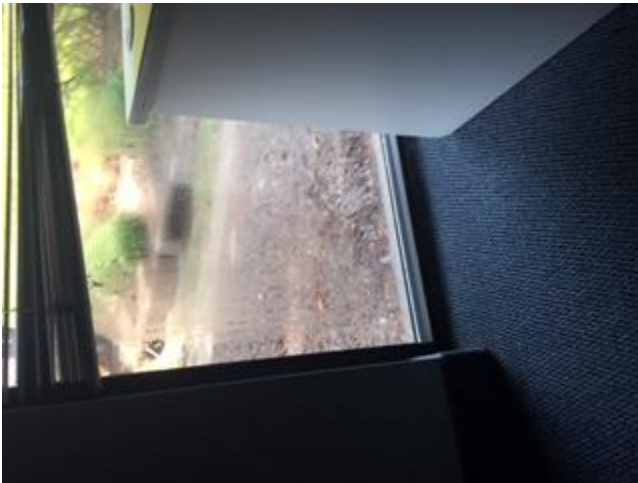
2nd window that needs to be replaced 1st floor.

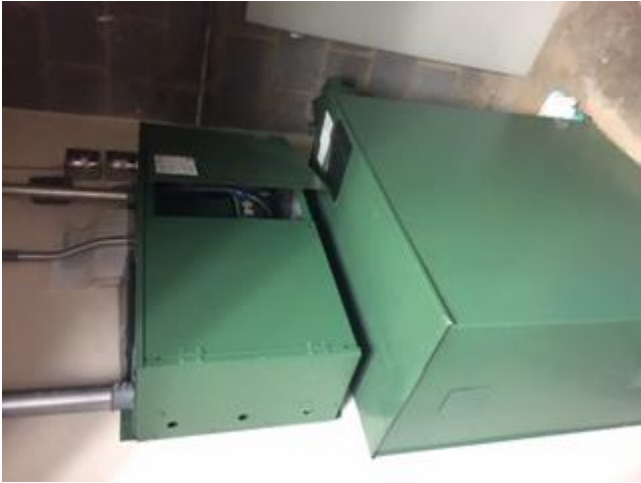
Elevator Mechanical room in good condition. ThyssenKrupp Cab and Elevator controls.

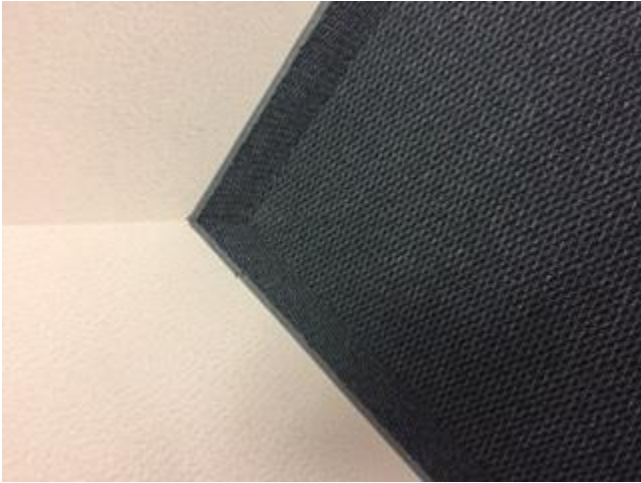
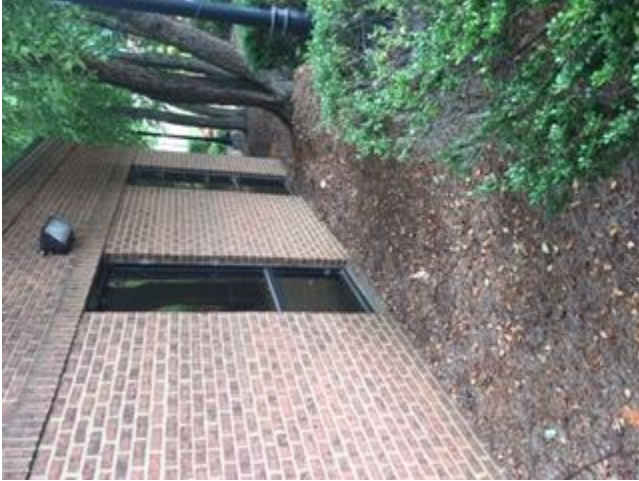
1st floor Carpet in great condition

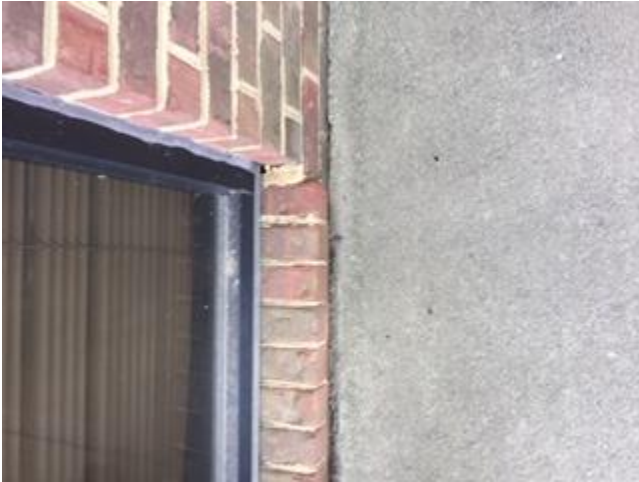
Exterior window deterioration
