# DRAINAGE INFRASTRUCTURE UPDATE

PUBLIC WORKS COMMITTEE
April 12, 2022

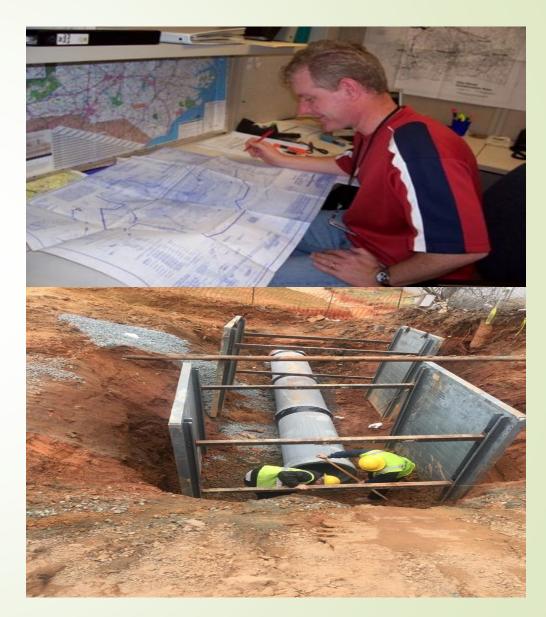
- Culvert: Hawthorne Road
- Ward: Southwest
- Damages: culvert settlement, shifting, invert undermining,
- Approximate Replacement Cost: \$ 3,000,000
- Emergency contract in place with consultant. Alternatives analysis complete. Full culvert replacement needed.
