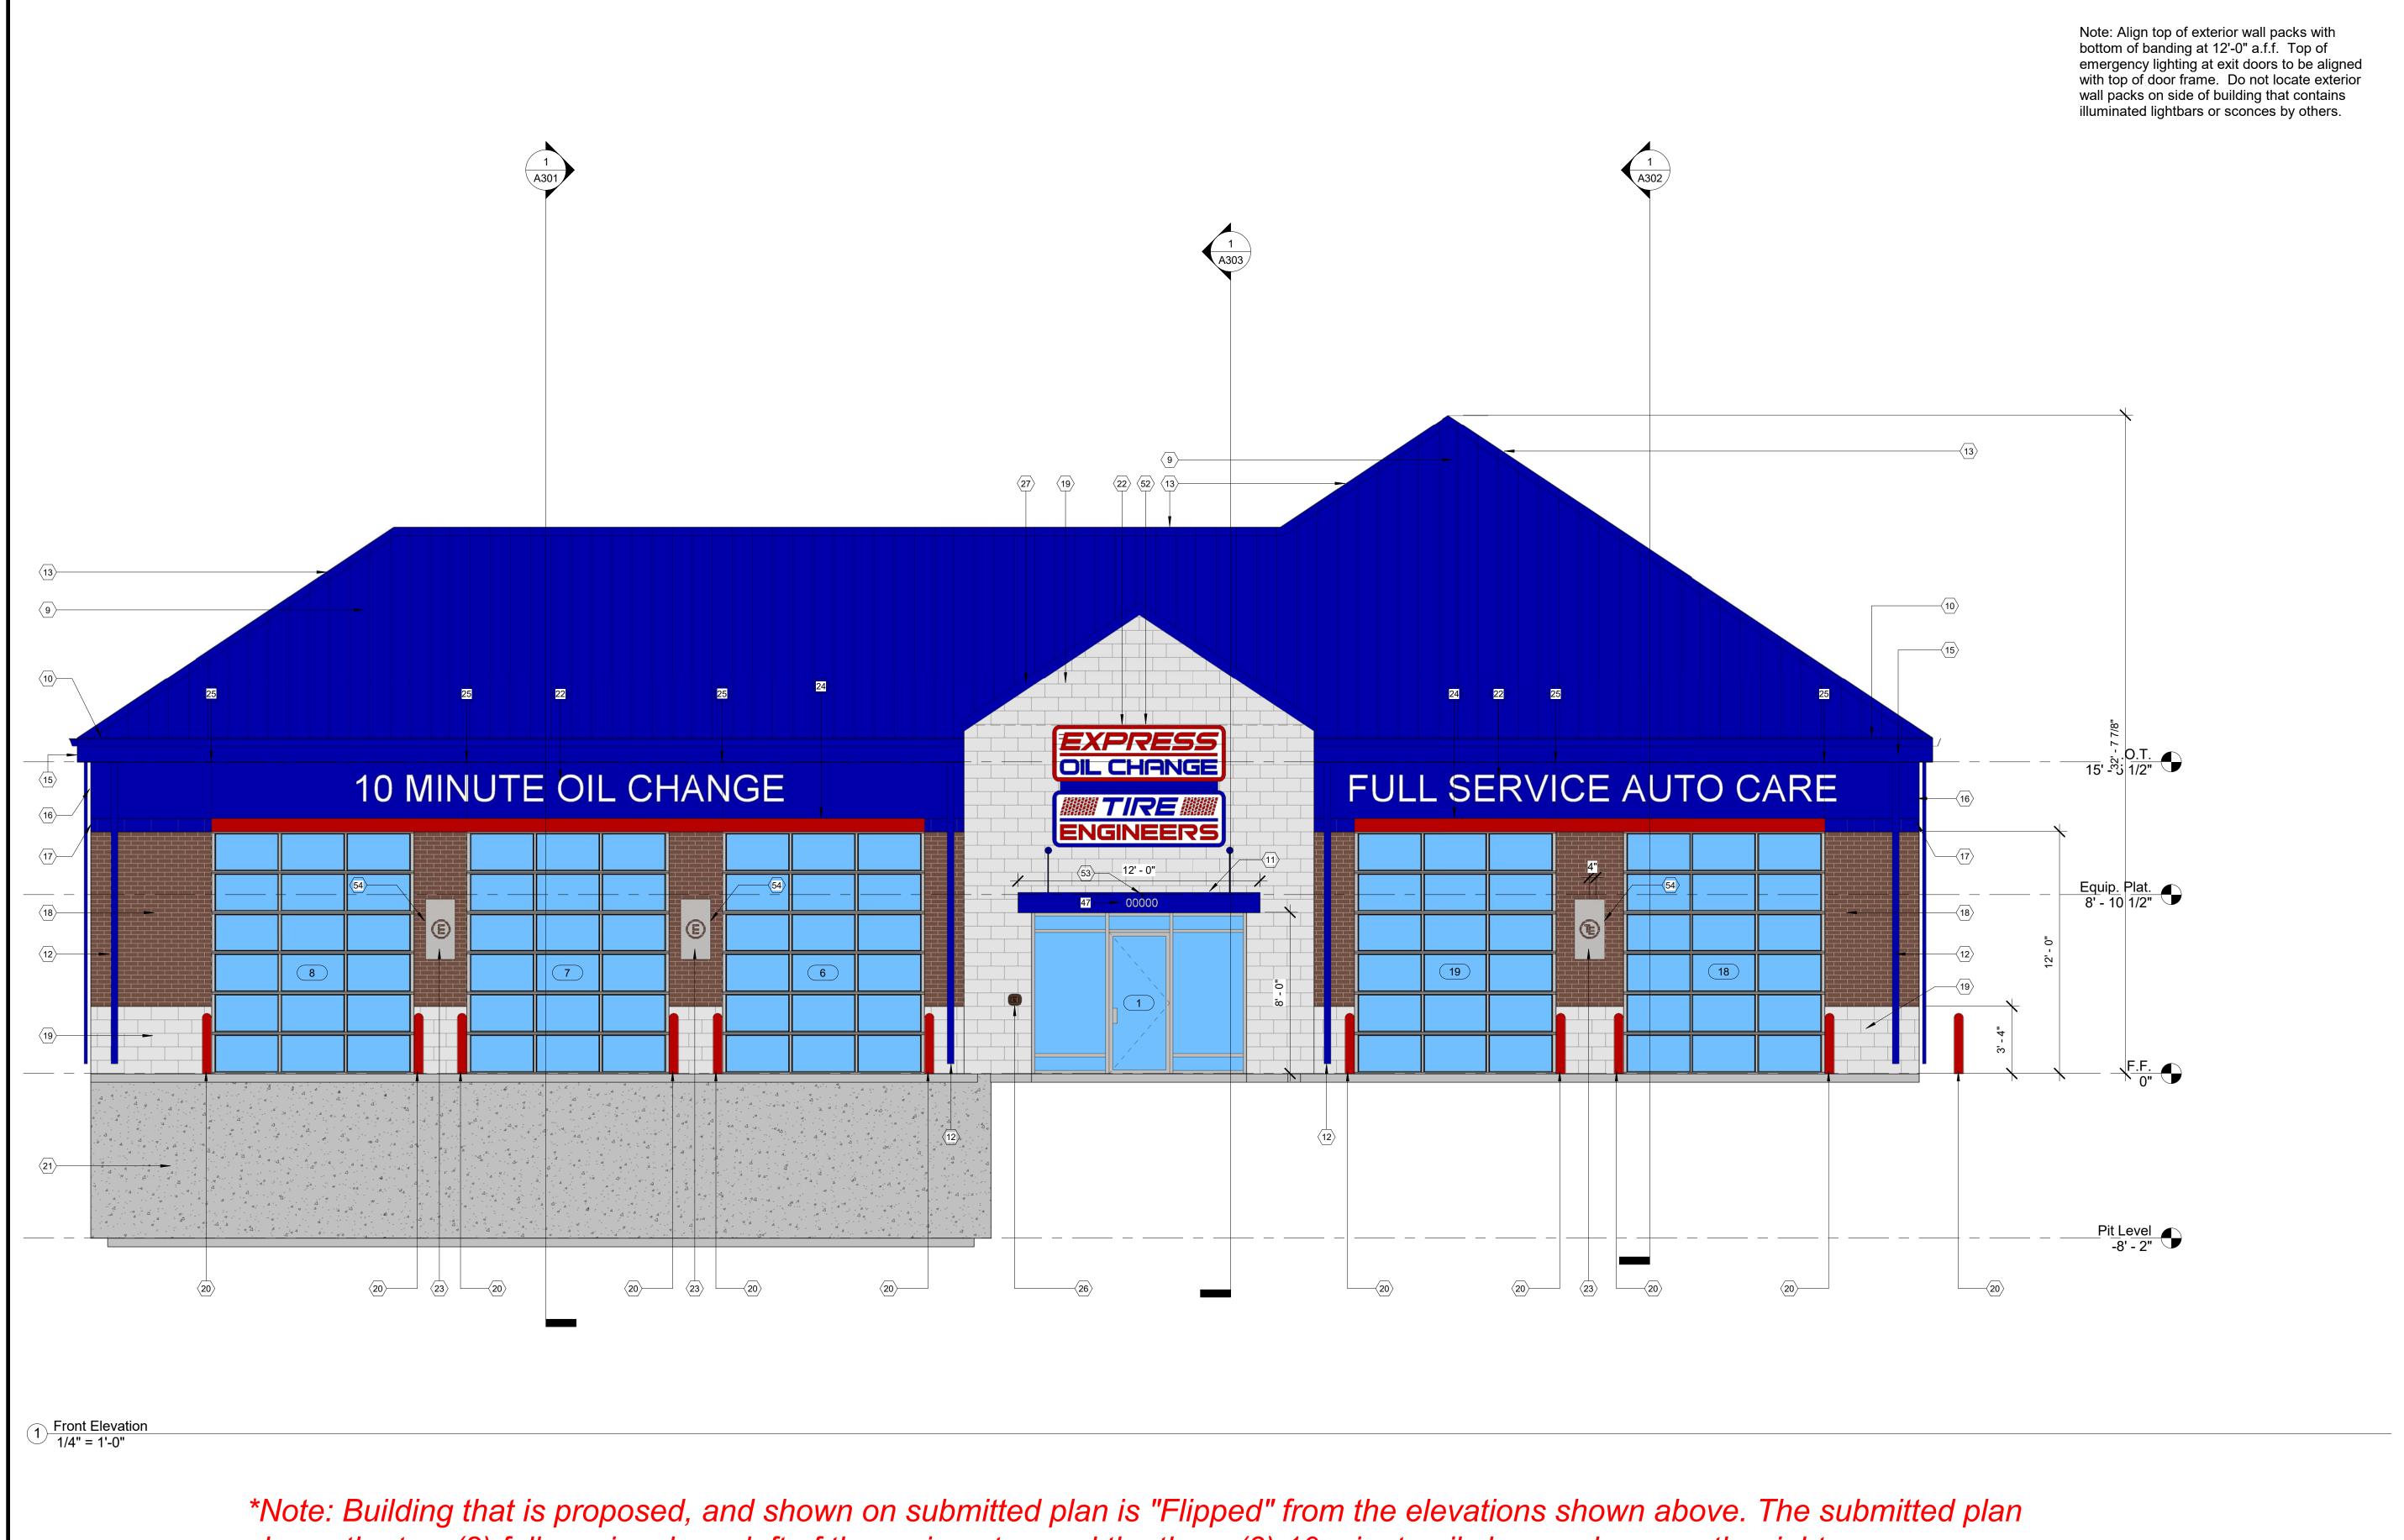
shows the two (2) full service doors left of the main entry, and the three (3) 10 minute oil change doors on the right.

*Note: Building that is proposed, and shown on submitted plan is "Flipped" from the elevations shown above. The submitted plan shows the two (2) full service doors left of the main entry, and the three (3) 10 minute oil change doors on the right.

The rear elevation would show three (3) oil change doors on the left, and two (2) full service doors on the right.

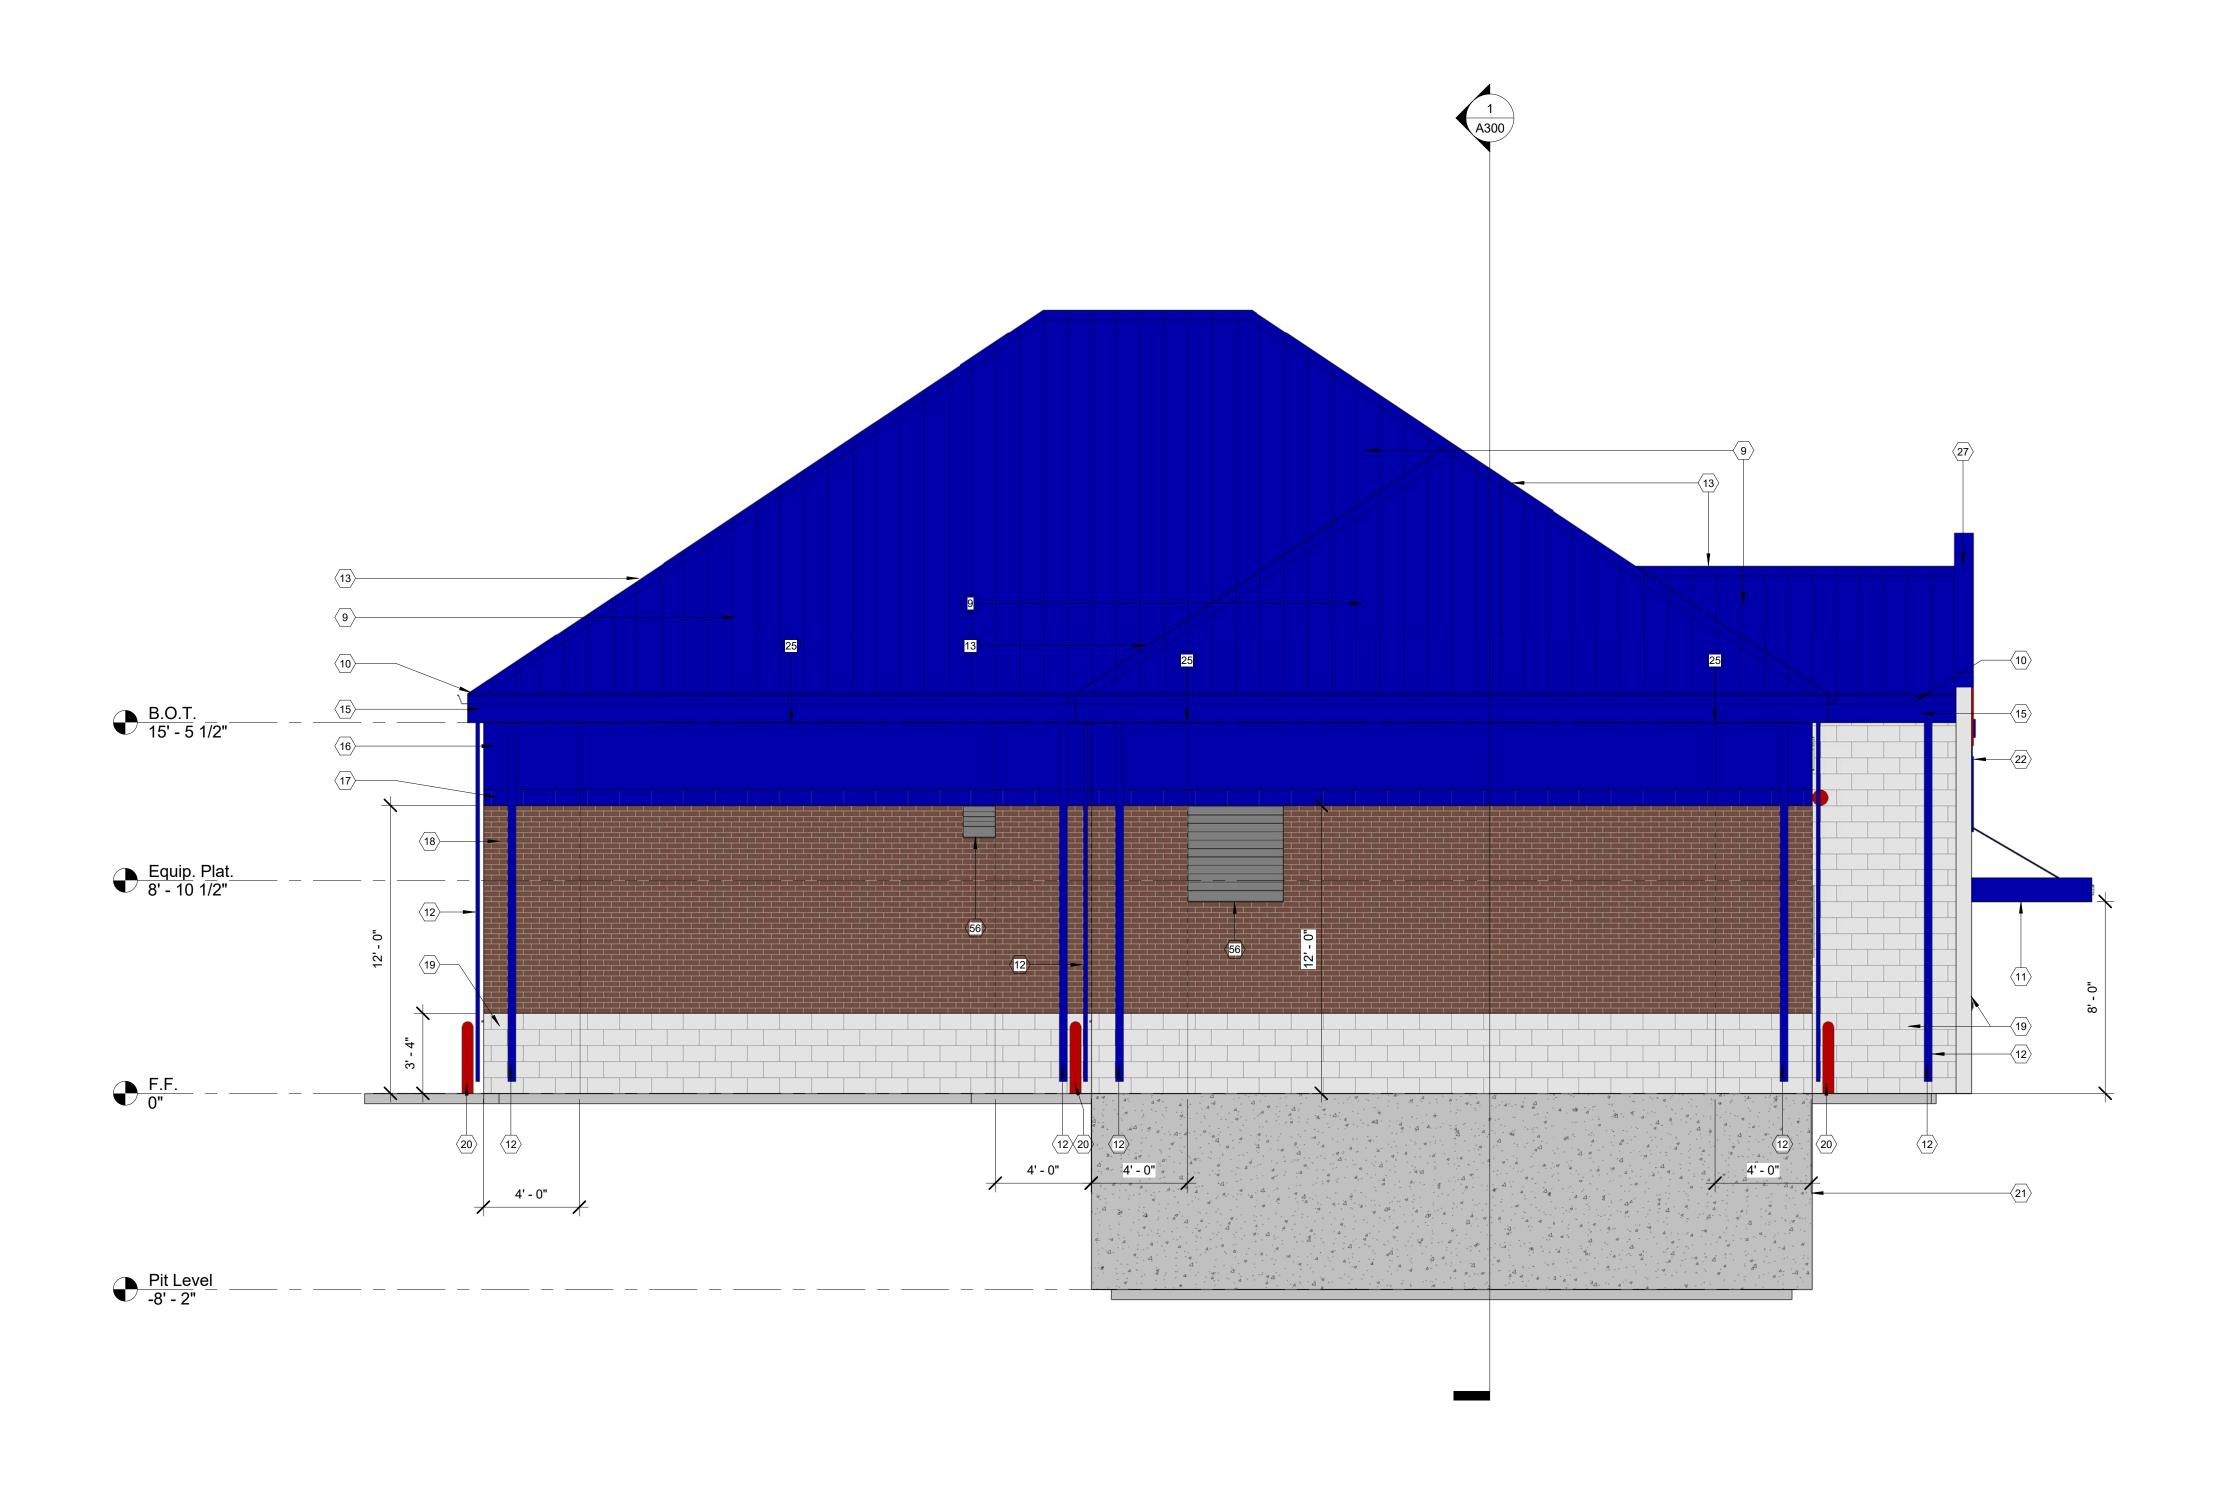
Note: Align top of exterior wall packs with bottom of banding at 12'-0" a.f.f. Top of emergency lighting at exit doors to be aligned with top of door frame. Do not locate exterior wall packs on side of building that contains illuminated lightbars or sconces by others.
